Viking Decommissioning Programmes: VDP2

Viking Satellites KD, LD, AR, Subsea tie-back Vixen VM, Viking Bravo Hub BA, BC, BP, BD and Associated Infield Pipelines

9th January 2019

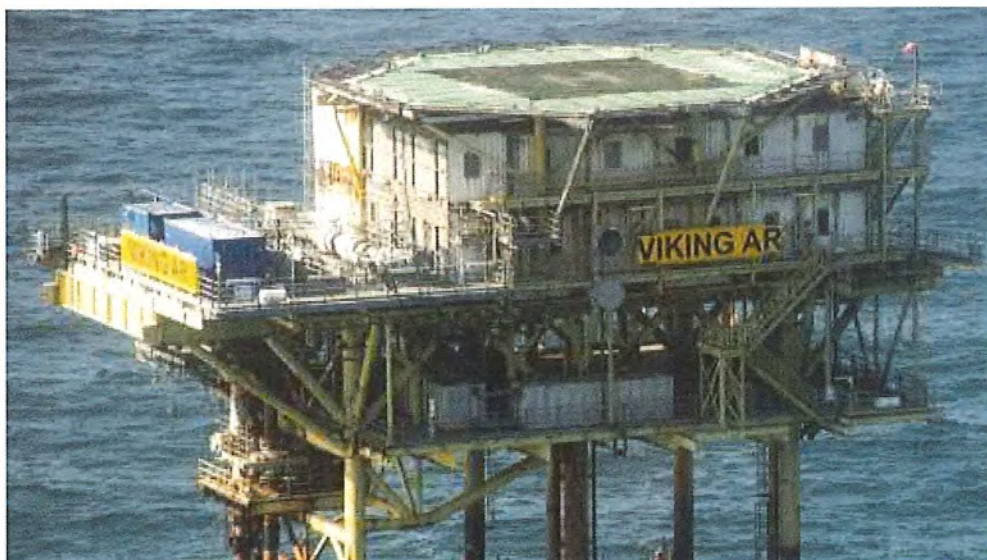
Figure 3.1.3 AR Topsides

The Viking AR topsides are a minimal facility designed for use as a NUI. The facilities extended 21m above LAT to the main deck. The Topsides weigh 1395Te have a deck size of 35m by 21m and comprise of a wellbay, test separator, gas driven compressor, local equipment room, gas power generation, pedestal crane and Helideck.

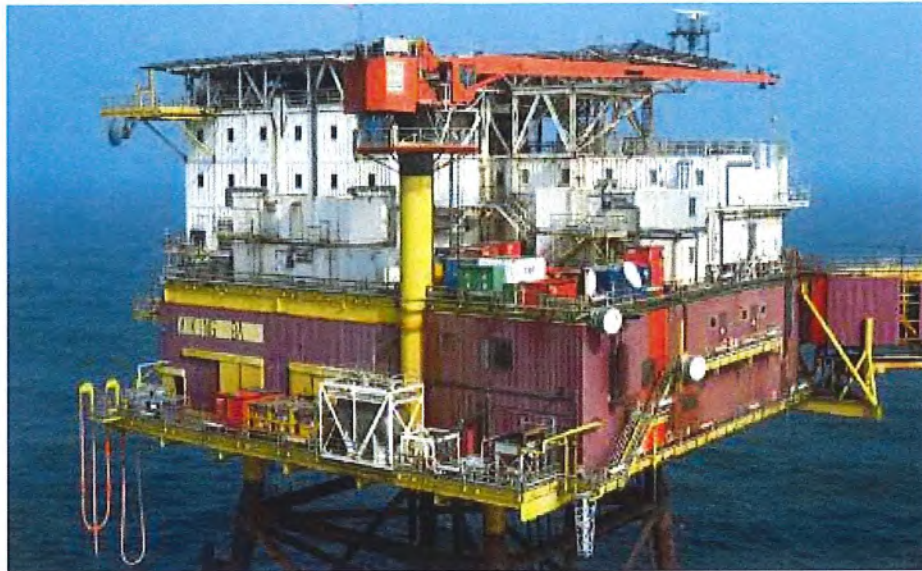
Figure 3.1.4 BA Topsides

The Viking BA topsides are a platform facility designed for accommodation to support the Viking Bravo Complex. The facilities extend 24m above LAT to the main deck. The Topsides weigh 2305 Te have a deck size of 39m by 32m and comprise of a wellbay, local equipment room, diesel power generation, pedestal crane and Helideck.

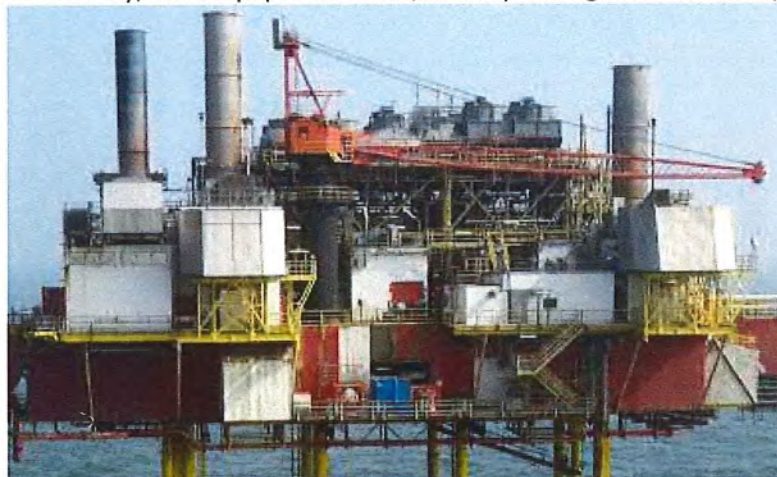
Figure 3.1.5 BC Topsides

The Viking BC topsides are a platform facility designed for power generation to support the Viking Bravo Complex and compression facilities to support gas export operations. The platform extends 24m above LAT to the main deck. The Topsides weigh 3376 Te have a deck size of 45m by 21m and comprise of a wellbay, local equipment room, diesel power generation and pedestal crane.

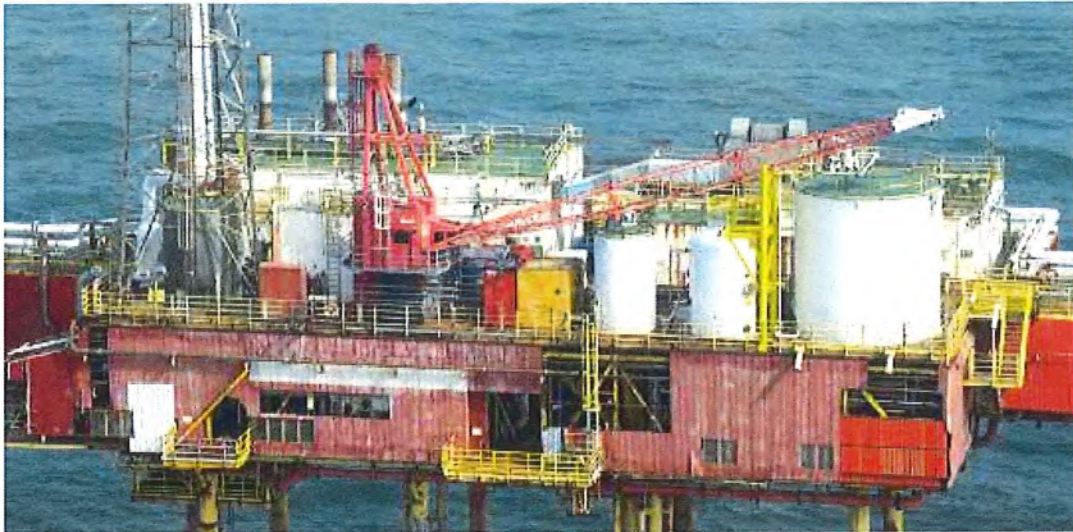
Figure 3.1.6 BP Topsides

The Viking BP topsides are a platform facility designed to process the Viking Area hydrocarbons which are then transported to TGT. The platform extends 24m above LAT to the main deck. The Topsides weigh 1782 Te have a deck size of 40m by 27m and comprise of a local equipment room, diesel power generation and pedestal crane.

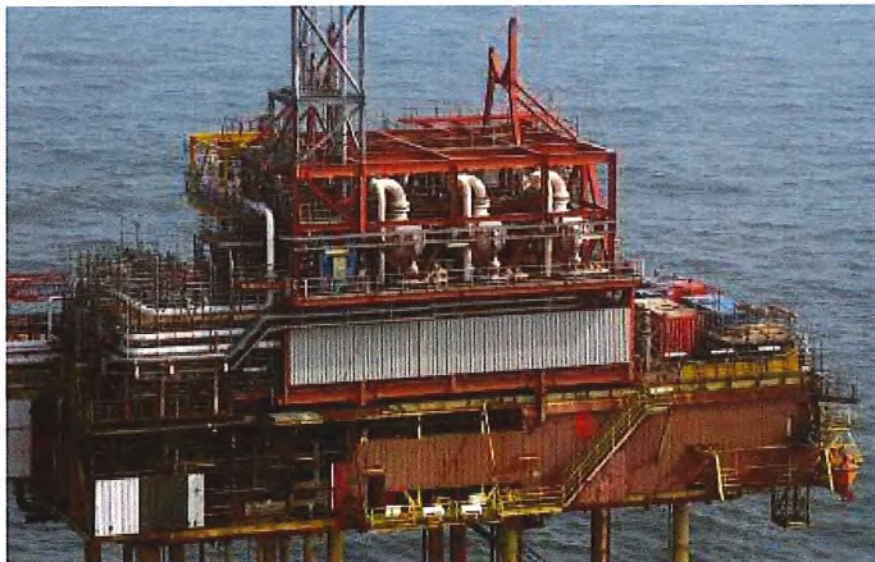
Figure 3.1.7 BD Topsides

The Viking BD topsides are a platform facility designed for hydrocarbon production from the wells and is utilised to separate the hydrocarbons before entering the processing facilities on Viking BP. The platform extends 24m above LAT to the main deck. The Topsides weigh 2302 Te have a deck size of 42m by 20m.
